Docket No. 272 - Development and Management Plan Inspection

Segment 2a Inspection

Date: October 12, 2006

Location: Segment 2a – Beseck Switching Station to Cheshire/Hamden Town Line

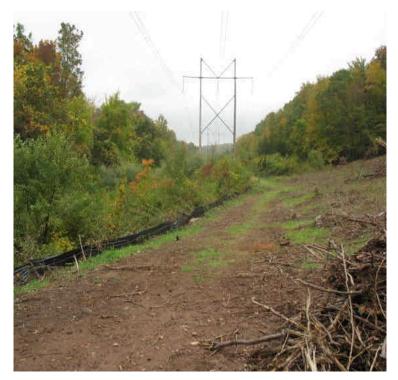
Silt fence looking north off High Hill Rd.

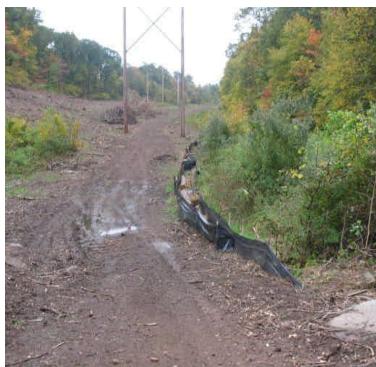
Silt fence above wetland off High Hill Rd.

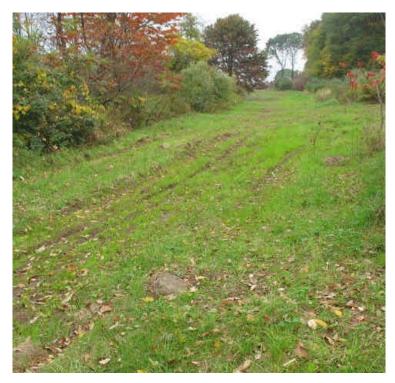
Grass growth off Stony Brook Rd.

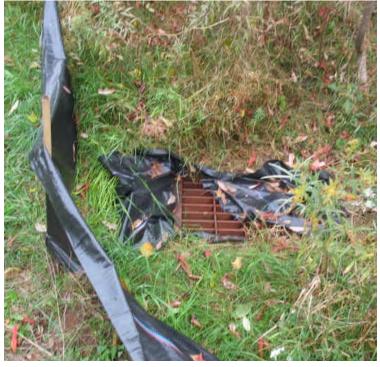
Catch basin controls in place off Stony Brook Rd.

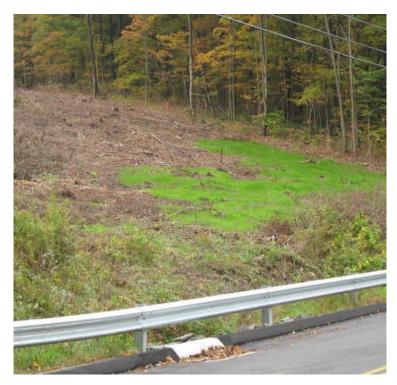
Increased grass growth noted off Mansion Rd.

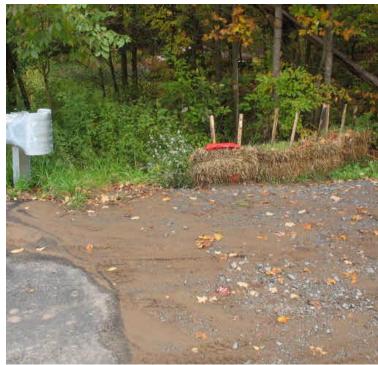
Areas of Inspection	Observation	Recommended Action	Corrected Action
	10/12/06		
Mansion Rd.	An existing riprap slope and culvert are present near the entrance from the road. No sediment was noted. 10/12/06	Continue to monitor and place controls in this area if traffic increases and adjacent soil becomes disturbed. 10/12/06	NA
	Grass growth continues on the steep slope and along the driveway. 10/12/06	Monitor slope for erosion. 10/12/06	Grass growth noted.
	Haybales installed at downgradient edge of the ROW entrance look secure. A few additional haybales should be placed to fully contain any stormwater runoff. No sedimentation has taken place to date. 10/5-10/12/06	Monitor and maintain haybales. Add haybales where necessary. 10/5- 10/12/06	Needs attention when feasible
Old Farm Rd.	Contractor has done an exceptional job selectively removing shrubs and leaving the majority of the vegetation intact. Very little potential for erosion exists in this area. 10/12/06	Continue to selectively cut vegetation in accordance with the D&M plan. 10/12/06	Most vegetation was left in place; this will help prevent erosion.

Extra haybales are needed to prevent runoff at Mansion Rd. entrance.

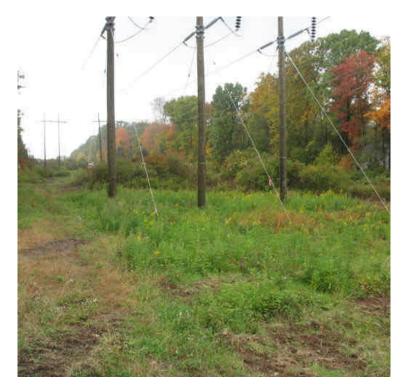
Shrubs left in place to stabilize slope off Old Farm Rd.

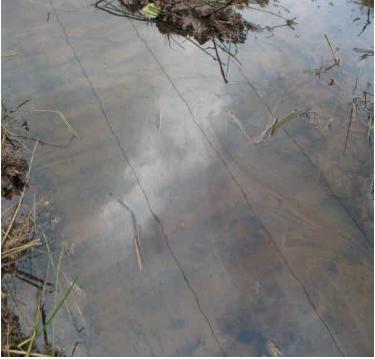
Spill control materials are being brought to sites when work is performed. 10/12/06	Always use spill control materials when working on equipment and during refueling. Replace as needed. 10/12/06	NA
Old Farm Rd.	The piece of equipment previously parked in a small non-jurisdcitional wetland finger off Old Farm Rd. was moved from the area. However, a small sheen was observed on the standing water here. 10/12/06	Park all heavy equipment away from wetlands and CBs when possible to prevent potential impacts. 10/12/06	Equipment was removed. Soak up sheen if feasible.
Additional Observations	NA	NA	NA

Sheen on water apparently resulting from the equipment that had been stored in a small, non-jurisdictional wetland finger off Old Farm Rd.
